## **APPENDIX G**

### **DPR Forms**

State of California — The Resources Agency  
DEPARTMENT OF PARKS AND RECREATION  
**PRIMARY RECORD**

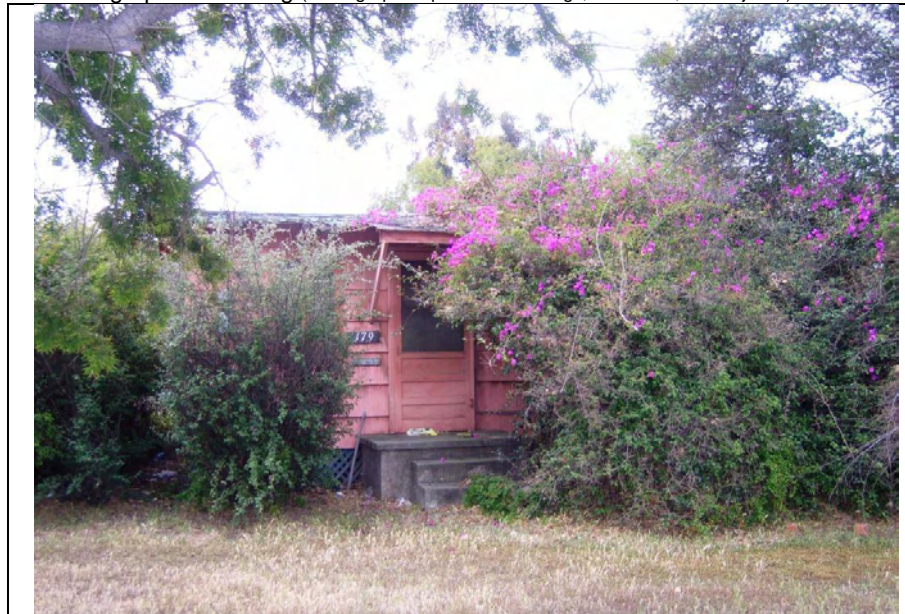
179 Oxford Street was constructed in 1930 in the Craftsman style. It is a one-story single family residential building located on the south side of Oxford Street. The residence has a wood frame, rectangular floor plan with a wood post foundation covered with latticework. The exterior is clad in asbestos shingle siding. The roof is a shed roof clad in standing seam metal sheets. On the north elevation, concrete steps lead to a covered stoop with a shed roof. Knee brackets support the shed roof. The primary entrance is located within the porch and consists of a single wood door. No windows could be seen from the street at the time of the survey. The building was covered with heavy vegetation at the time of the survey. There is also a wood garage with no doors on the property.

View looking south at the building.

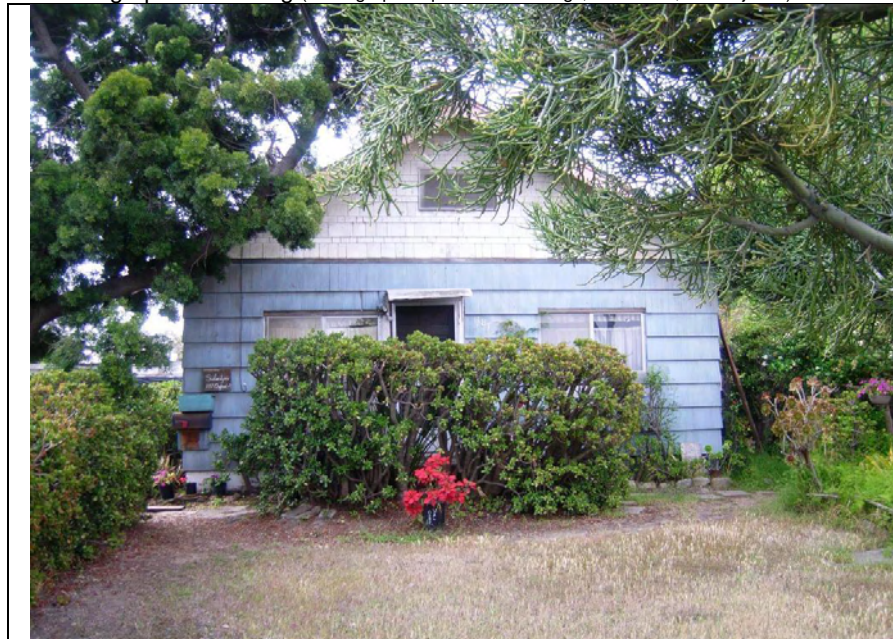
187 Oxford Street was constructed in 1920 in the Craftsman style. It is a one-story single family residential building located on the south side of Oxford Street. The residence has a wood frame, rectangular floor plan with a concrete foundation. The exterior is clad in asbestos shingle and wood shingle siding. The roof is a moderately-pitched front gable roof with shallow eaves and clad in an asphalt roll. On the north elevation, concrete steps lead to a covered stoop with a shed hood. Knee brackets support the hood. The primary entrance is located within the porch and consists of a single wood door. The windows consist of aluminum sliding windows and a dormer window on the west elevation. There is one chimney located within the roofline. Modifications to the building include the replacement siding windows and doors. Landscape features include large bushes and mature trees. There is also a wood garage with no doors on the property.

View looking south at the building.

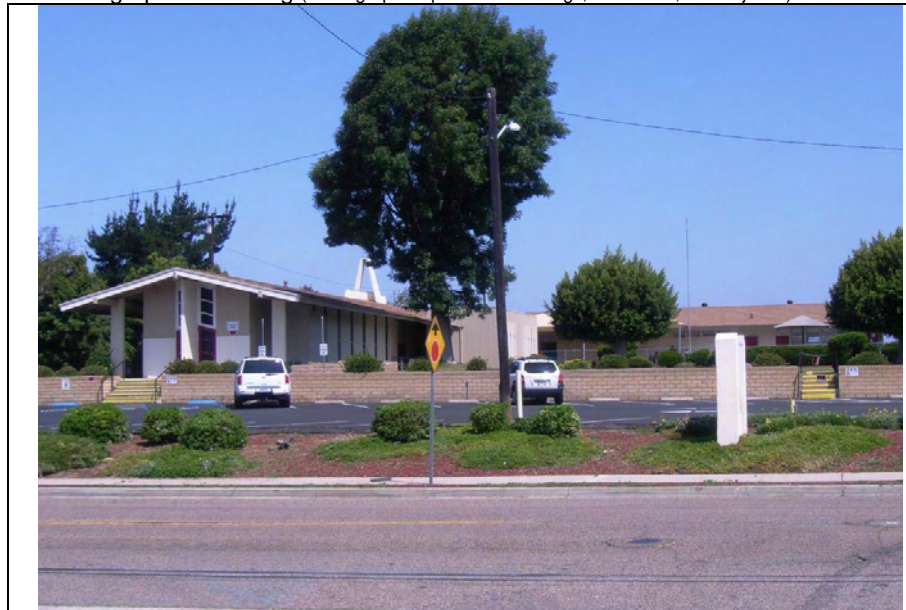
267 E Oxford Street was constructed circa 1965 in the Modern style. It is a one-story ecclesiastic building located on the north side of E Oxford Street between Nolan and Melrose avenues. The church building has a wood frame, L-shaped floor plan with a concrete foundation. The exterior is clad in stucco siding. The roof is a widely-pitched front and side gable roof with overhanging eaves and clad in asphalt. On the south elevation, concrete steps lead to a recessed walkway. The primary entrance is located within the recessed walkway and could not be seen from the street at the time of the survey. The windows are primarily stained glass windows. Additions include front gable buildings located to the east of the building. There appear to be no modifications to the building. Landscape features include a parking lot with flowerbeds and mature trees.

View of the building looking north.

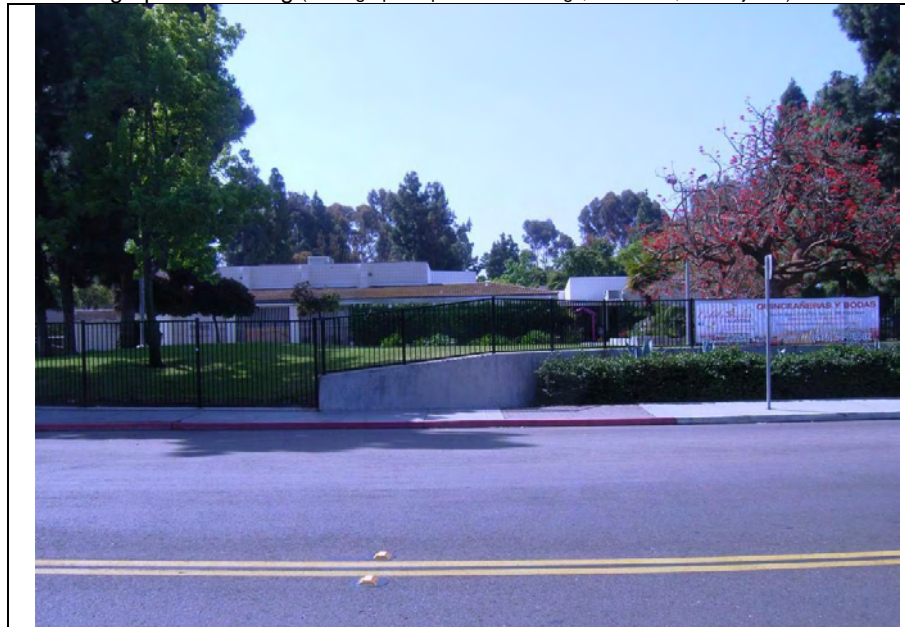
View looking south at the building.

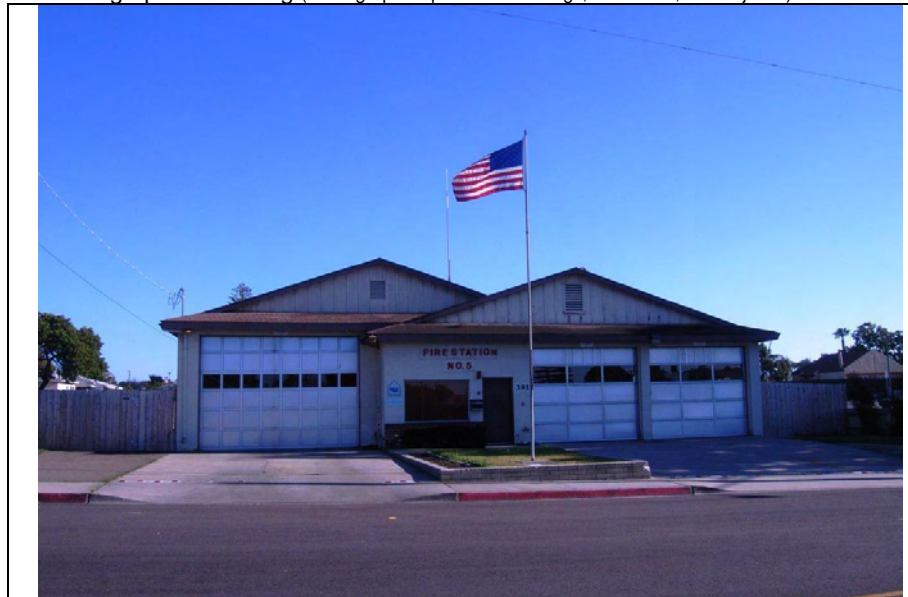
View looking south at the building.

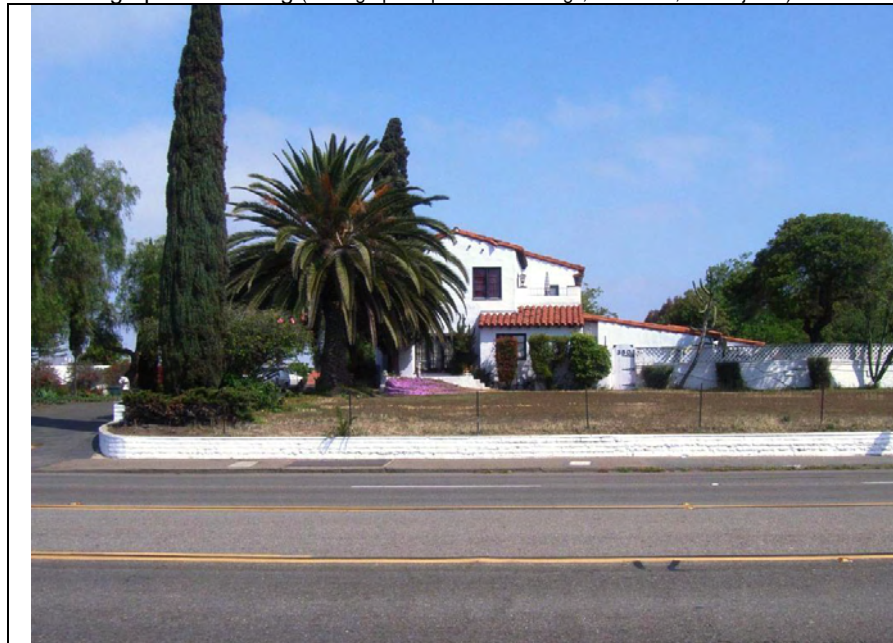
View looking north at a building.

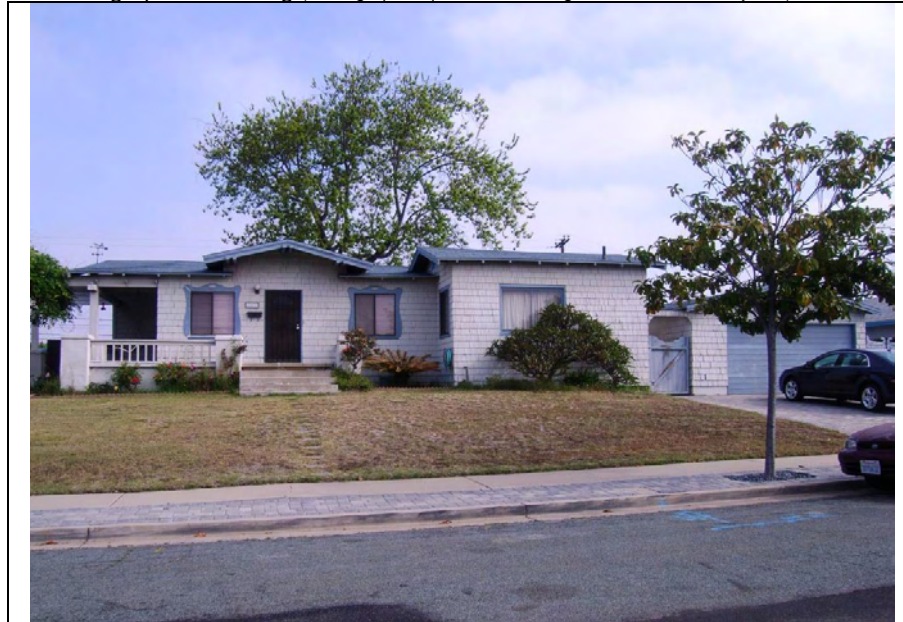
View looking north at the building.

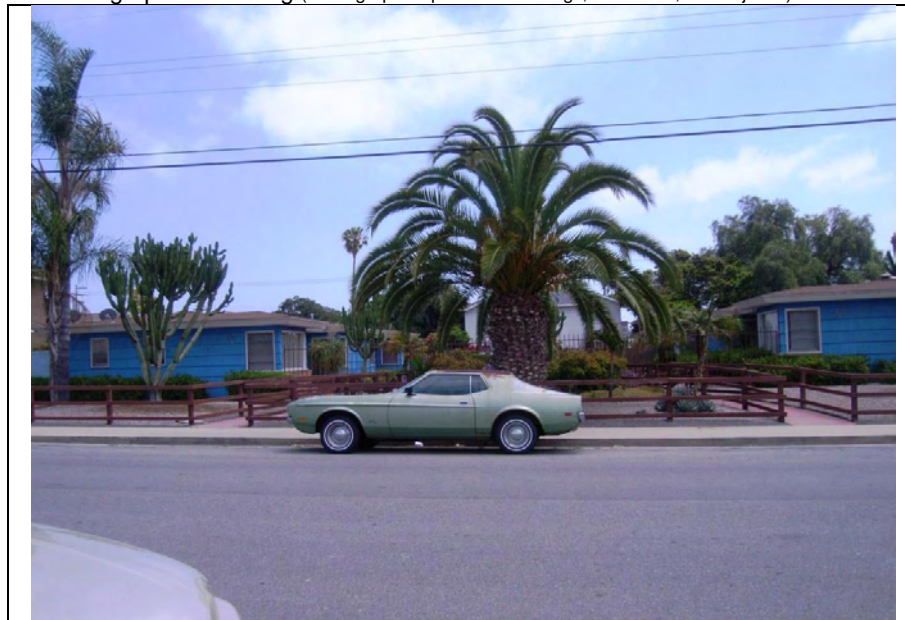
View looking south at the complex.

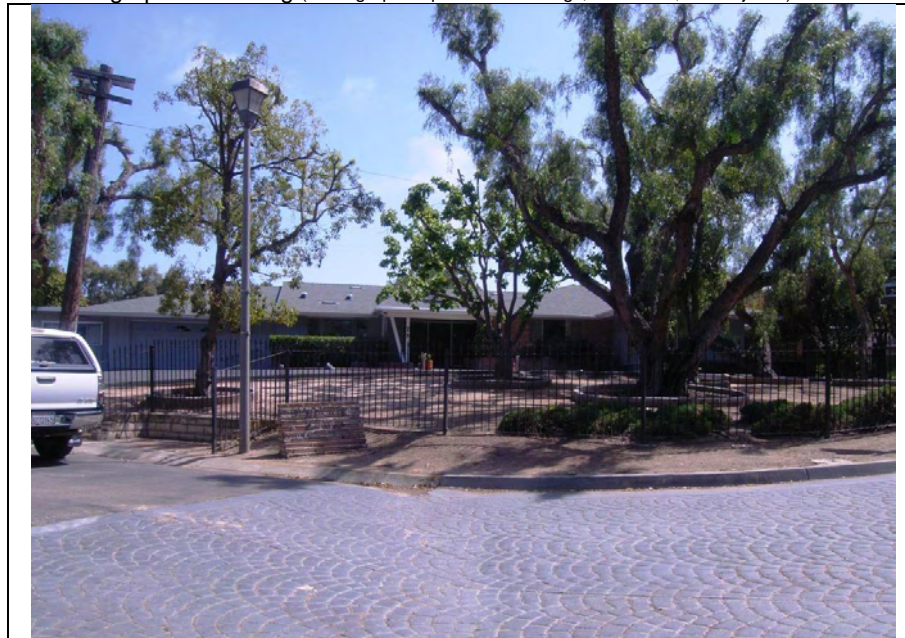
View looking south at the building.

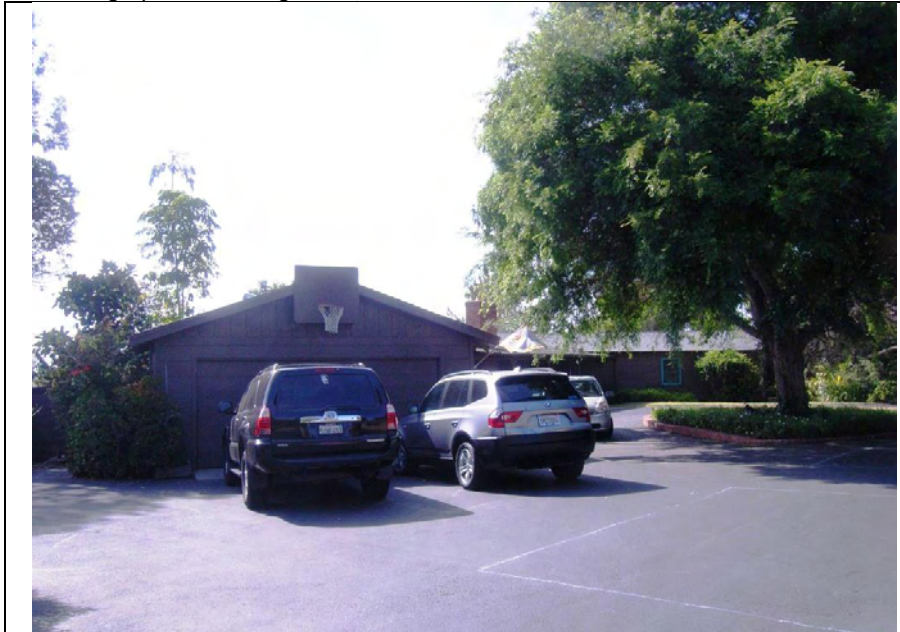
View looking east at the building.

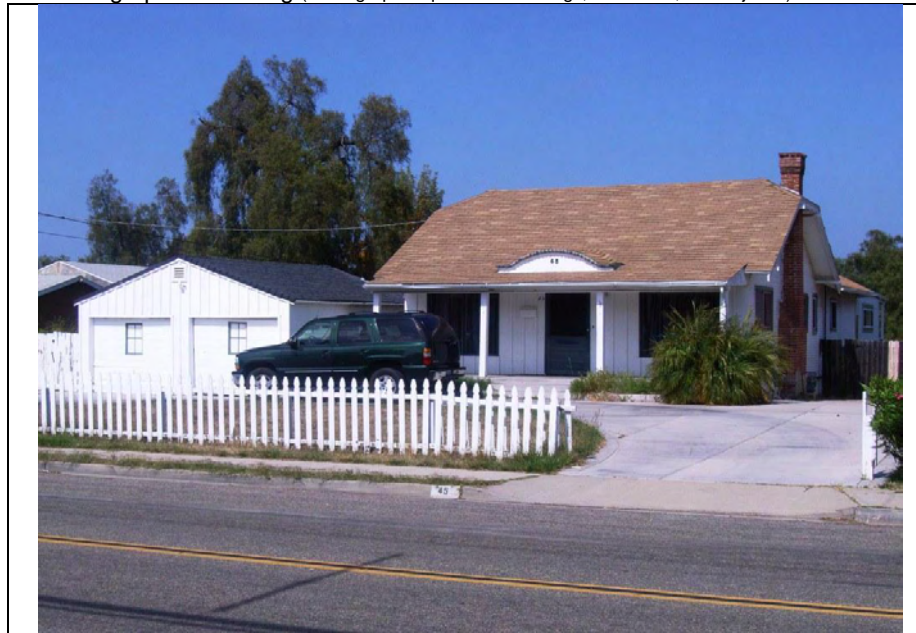
45 Second Avenue was constructed in 1930 in the Craftsman style. It is a one- and one-half story single family residential building located on the east side of Second Avenue, between Chula Vista and Sea Vale streets. The residence has a wood frame, rectangular floor plan with a concrete foundation. The exterior is clad in board-and-batten, and wood clapboard siding. The roof is a moderately-pitched side clipped gable roof with an eyelet dormer hood and clad in an asphalt roll. On the west elevation, concrete steps lead to a full-width recessed porch. Squared posts support the porch roof. The primary entrance is located within the porch and consists of a single wood door and wood screen door. The windows consist of fixed picture and vinyl sliding windows. There is one chimney located on the south elevation exterior lateral. There is also a detached two-car garage located to the north of the residence. Additions include one-story additions to the rear of the building. Modifications to the building include the re-fenestration and residing of the main façade, and the replacement of windows. Landscape features include a U-shaped driveway, small garden beds in front of the porch and a white picket fence surrounding the property.

View looking west at the building.

45 SECOND AV is not recommended eligible as a Chula Vista Historic Resource under any NRHP or CRHR or local criteria. In considering the building within the historic context prepared for this survey, it does not appear to be associated with any significant themes or patterns in history and therefore not eligible for Criteria A or 1. Additionally, no significant persons were identified in association with the property and it is not recommended eligible under Criteria B or 2. Although 45 SECOND AV possesses some stylistic features of the Craftsman style, it is not a good representative of the style and is not recommended eligible under Criteria C or 3.

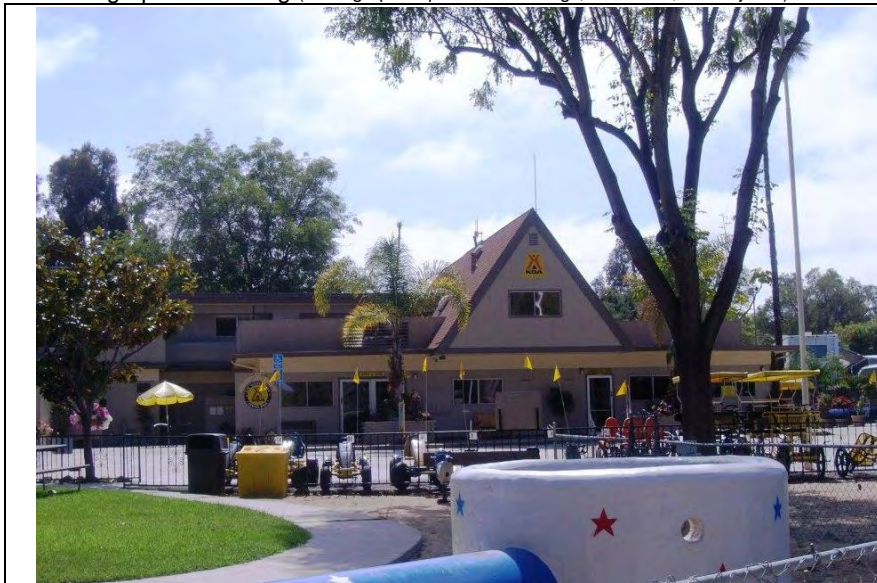
111 N. Second Avenue was constructed circa 1965 in no architectural style. It is a one- and one-half story KOA Campground building located on the east side of N. Second Avenue, south of Highway 54. The community building has a wood frame, rectangular floor plan with a concrete foundation. The exterior is clad in vertical wood board siding. The roof is a steeply-pitched front gable roof sitting atop a flat section of the roof and clad in asphalt shingle. The building has widely-overhanging eaves. The primary entrance is located on the east elevation. A concrete sidewalk lines the front of the façade. The windows consist of aluminum sliding windows. Landscape features include walled in flower beds with palm trees immediately surrounding the building, as well as the KOA campground which consists of modern RV trailers and one-story log cabins.

View looking south at the main building.

111 N SECOND AV is not recommended eligible as a Chula Vista Historic Resource under any NRHP or CRHR or local criteria. In considering the building within the historic context prepared for this survey, it does not appear to be associated with any significant themes or patterns in history and therefore not eligible for Criteria A or 1. Additionally, no significant persons were identified in association with the property and it is not recommended eligible under Criteria B or 2. Because 111 N SECOND AV does not possess any stylistic features of an architectural style, it is not recommended eligible under Criteria C or 3.

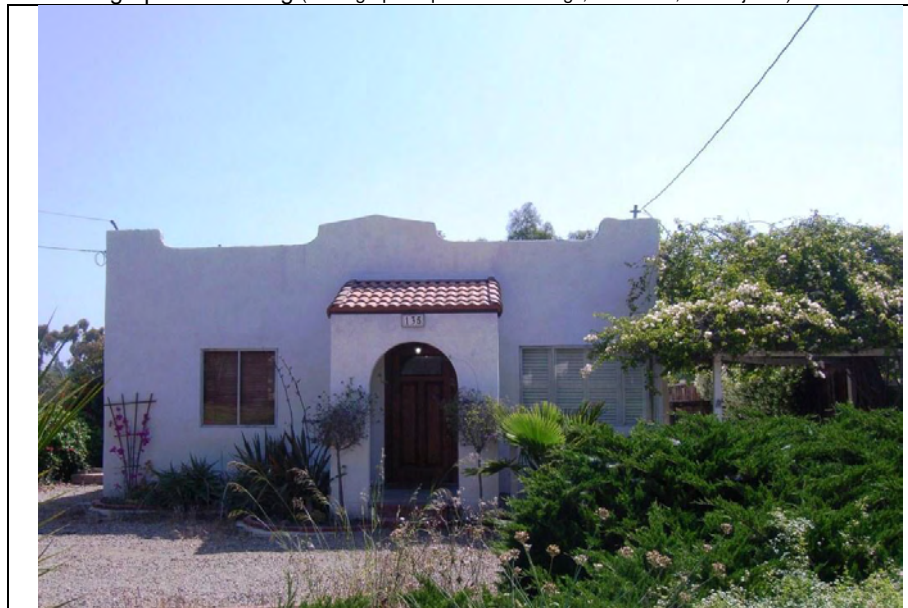
135 Second Avenue was constructed in 1926 in the Spanish Colonial Revival style. It is a one-story single family residential building located on the east side of Second Avenue. The residence has a wood frame, rectangular floor plan with a concrete foundation. The exterior is clad in stucco siding. The roof is flat with a raised parapet. On the east elevation, a concrete walkway with steps leads to a partial-width porch with a shed roof covered in red clay tiles. The primary entrance is located within the porch and consists of a single wood door. The windows consist of aluminum sliding windows. There is a carport on the south side of the house. Modifications to the building include the replacement windows and doors. Landscape features include a gravel yard and bushes within flower beds.

View looking east at the building.

135 SECOND AV is not recommended eligible as a Chula Vista Historic Resource under any NRHP or CRHR or local criteria. In considering the building within the historic context prepared for this survey, it does not appear to be associated with any significant themes or patterns in history and therefore not eligible for Criteria A or 1. Additionally, no significant persons were identified in association with the property and it is not recommended eligible under Criteria B or 2. Although 135 SECOND AV possesses some stylistic features of the Spanish Colonial Revival style, it is not a good representative of the style and is not recommended eligible under Criteria C or 3.

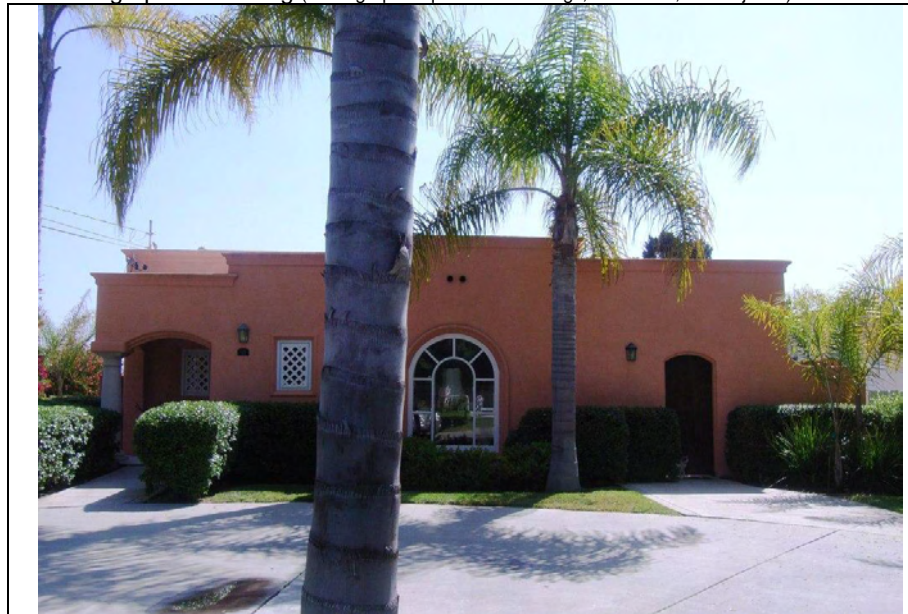
145 Second Avenue was constructed circa 1940 in the Mediterranean Revival style. It is a one-story single family residential building located on the east side of Second Avenue. The residence has a wood frame, rectangular floor plan with a concrete foundation. The exterior is clad in stucco siding. The roof is flat with a raised parapet. On the east elevation, a concrete walkway leads to a corner recessed porch. A single column supports the porch roof. The primary entrance is located within the porch. The windows consist of vinyl windows with latticework and a central arched window on the main facade. There is also a winged wall on the south section of the building. Modifications to the building include the replacement of windows and doors. Landscape features include large mature palm trees, a central concrete driveway and a side driveway.

View looking east at the building.

145 SECOND AV is recommended eligible as a Chula Vista Historic Resource under NRHP, CRHR and local criteria. In considering the building within the historic context prepared for this survey, it does not appear to be associated with any significant themes or patterns in history and therefore not eligible for Criteria A or 1. Additionally, no significant persons were identified in association with the property and it is not recommended eligible under Criteria B or 2. 145 SECOND AV as an excellent local example of the Spanish Colonial Revival style, and as such is recommended eligible as a Chula Vista Historic Resource under Criterion 3. Character defining features of the Spanish Colonial Revival style include the smooth stucco walls, raised patterned parapet, arched windows and entryways, and recessed porch. Following the same reasons, it is also eligible for the California Register of Historical Resources and National Register of Historic Places, on the local level, under Criterion 3 (CRHR) and Criterion C (NRHP). The building retains a significant degree of its building materials dating to the period of significance, especially in comparison to other similar properties. Overall it retains a high degree of integrity, especially of design, materials, and craftsmanship.

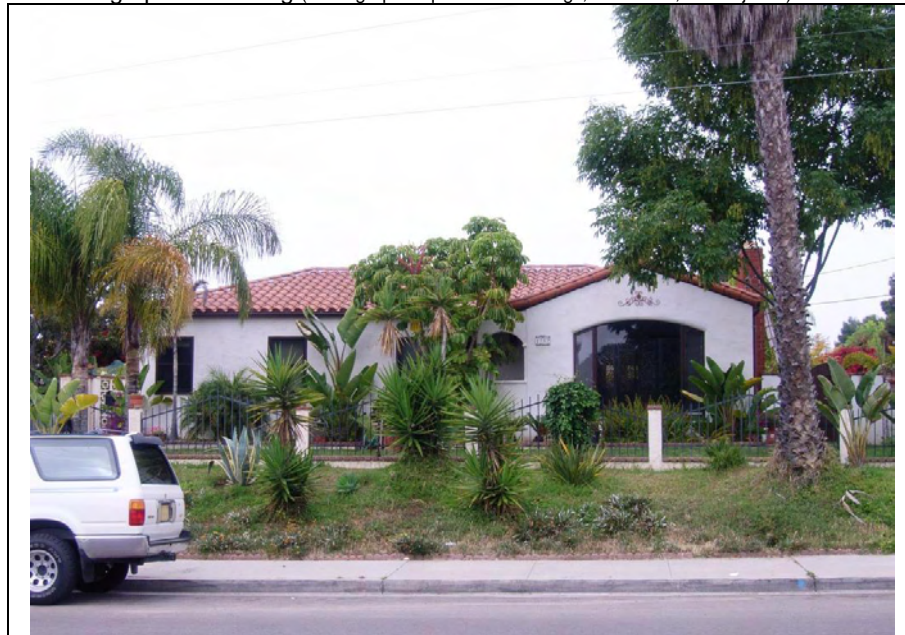
1282 Second Avenue was constructed in 1935 in the Spanish Colonial Revival style. It is a one-story single family residential building located on the west side of Second Avenue between Palomar and Kennedy streets. The residence has a wood frame, rectangular floor plan with a concrete foundation. The exterior is clad in stucco siding. The roof is a widely-pitched front and side gable roof with shallow eaves and clad in red clay tiles. On the east elevation, a concrete walkway leads to a corner recessed porch. The primary entrance is located within the porch and could now be seen from the street at the time of the survey. The windows consist of aluminum sash windows. There is also a large fixed picture window located on the west elevation at the front gable projection. There is one chimney located on the north elevation exterior lateral. Landscape features include mature trees and a grass lawn, and the property is surrounded by a stucco and iron fence. There is a detached garage at the rear of the property.

View looking north at the building.

1282 SECOND AV is not recommended eligible as a Chula Vista Historic Resource under any NRHP or CRHR or local criteria. In considering the building within the historic context prepared for this survey, it does not appear to be associated with any significant themes or patterns in history and therefore not eligible for Criteria A or 1. Additionally, no significant persons were identified in association with the property and it is not recommended eligible under Criteria B or 2. Although 1282 SECOND AV possesses some stylistic features of the Spanish Colonial Revival style, it is not a good representative of the style and is not recommended eligible under Criteria C or 3.

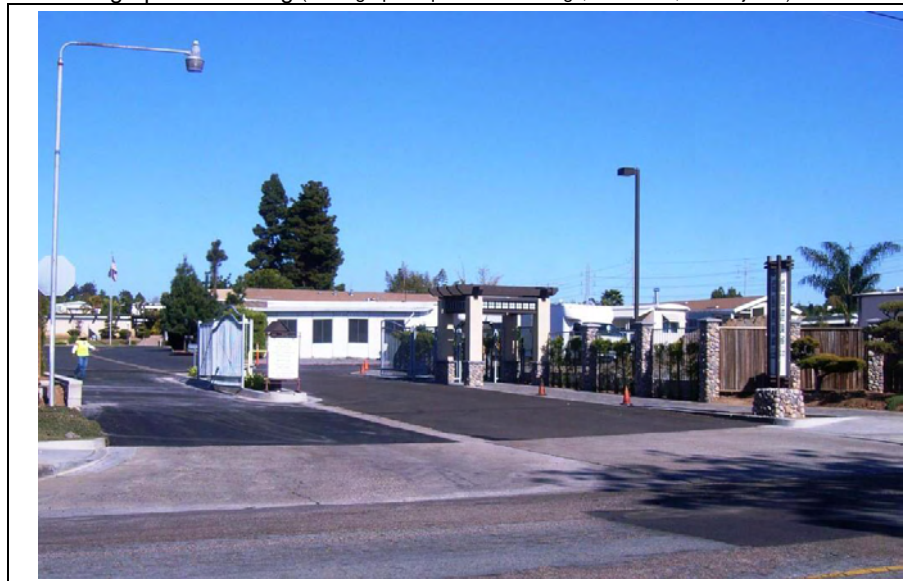
View looking east at the entrance.

1425 SECOND AV is recommended eligible as a Chula Vista Historic Resource under Criterion 1 for its association with Chula Vista's Community Planning and Development as well as its Japanese Ethnic Heritage. during the City Maturation period. During the 1960s, mobile home estates were constructed to meet the growing population of Chula Vista. Japanese developer, Roy Muraoka was an important Japanese American developer in Chula Vista who built this mobile home park at 1425 Second Avenue in 1963. Following the same reasons, it is also eligible for the California Register of Historical Resources and National Register of Historic Places, on the local level, under Criterion 1 (CRHR) and Criterion A (NRHP) under the area of significance of Ethnic Heritage and Community Planning and Development. 1425 SECOND AV is also eligible as a Chula Vista Historic Resource under Criterion 2 for its association with Roy Muraoka, who made significant contributions locally as a Japanese businessman. Following the same reasons, it is also eligible for the California Register of Historical Resources and National Register of Historic Places, on the local level, under Criterion 2 (CRHR) and Criterion B (NRHP). Finally, 1425 SECOND AV is also recommended eligible under Criterion 3 as an excellent example of the mobile estate park, which was a typical residential neighborhood development during and after World War II. Following the same reasons, it is also eligible for the California Register of Historical Resources and National Register of Historic Places, on the local level, under Criterion 3 (CRHR) and Criterion C (NRHP). The building retains a significant degree of its building materials dating to the period of significance, especially in comparison to other similar properties. Overall it retains a high degree of integrity, especially of design, materials, and craftsmanship. The period of significance for the property is 1963-1967.

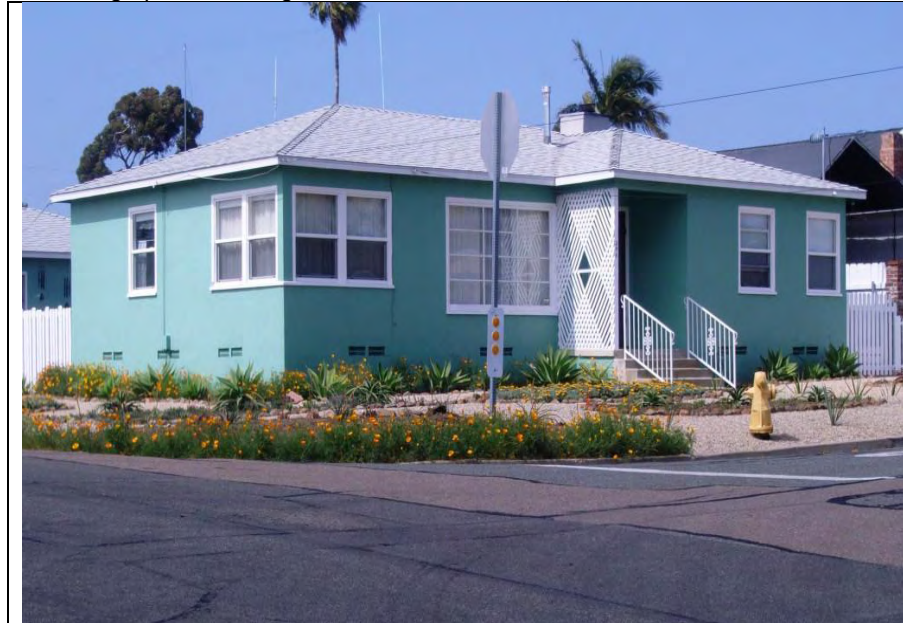
295 Shirley Street was constructed in 1948 in the Tract Ranch style. It is a one-story single family residential building located on the north side of Shirley Street. The residence has a wood frame, rectangular floor plan with a concrete foundation. The exterior is clad in stucco siding. The roof is a widely-pitched hipped roof with shallow eaves and clad in asphalt shingles. On the south elevation, concrete steps with metal railings lead to a partial-width recessed porch with latticework screening. The main façade is asymmetrical. The primary entrance is located within the porch and consists of a single wood door. The windows consist of vinyl sash and fixed multi-light windows. There is one chimney located in the roof surface. There is a detached garage located on the parcel. Modifications to the building include the replacement of windows and doors and siding. Landscape features include a gravel yard with flower beds.

View taken looking northeast.

295 SHIRLEY ST is not recommended eligible as a Chula Vista Historic Resource under any NRHP or CRHR or local criteria. In considering the building within the historic context prepared for this survey, it does not appear to be associated with any significant themes or patterns in history and therefore not eligible for Criteria A or 1. Additionally, no significant persons were identified in association with the property and it is not recommended eligible under Criteria B or 2. Although 295 SHIRLEY ST possesses some stylistic features of the Tract Ranch style, it is not a good representative of the style and is not recommended eligible under Criteria C or 3.

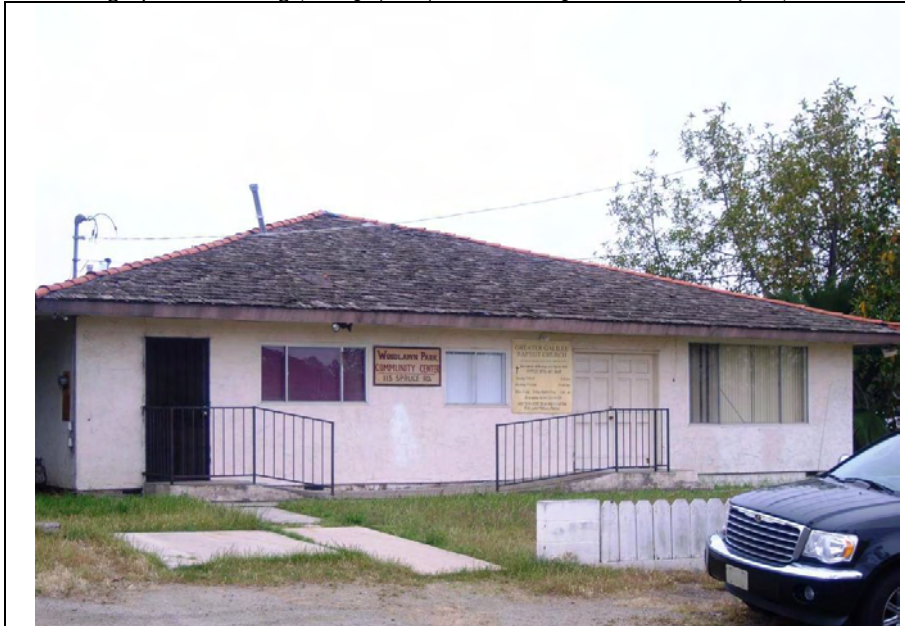
115 Spruce Road was constructed circa 1960 in the Modern style. It is a one-story community building located on the south side of Spruce Road. The community building has a wood frame, rectangular floor plan with a concrete foundation. The exterior is clad in stucco. The roof is a widely-pitched hipped roof with overhanging eaves and clad in asphalt shingles. On the north elevation, concrete walkway and steps lead to an open stoop. The primary entrance is located within the stoop and consists of two single wood doors. The windows consist of aluminum sliding and fixed windows.

View looking southeast at the building.

115 SPRUCE RD is not recommended eligible as a Chula Vista Historic Resource under any NRHP or CRHR or local criteria because of its loss of integrity. In considering the building within the historic context prepared for this survey, it does not appear to be associated with any significant themes or patterns in history and therefore not eligible for Criteria A or 1. Additionally, no significant persons or events were identified in association with the property and it is not eligible under Criteria B or 2. Although 115 SPRUCE RD possesses some stylistic features of the Modern style, it is not a good representative of the style and is not eligible under Criteria C or 3.

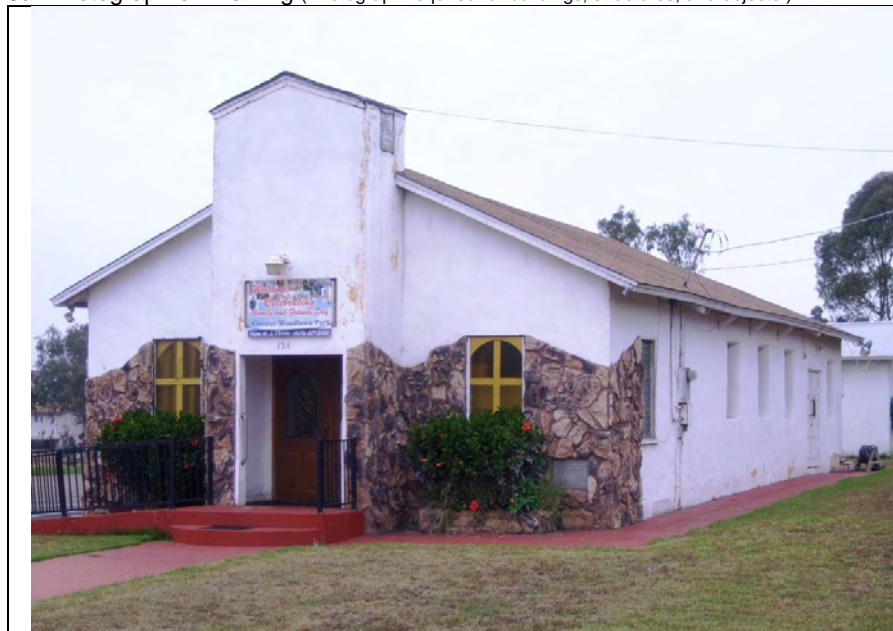
124 Spruce Road was constructed circa 1940 and has no architectural style. It is a one-story church building located on the north side of Spruce Road between Orange and Sycamore drives. The church has a wood frame, rectangular floor plan with a concrete foundation. The exterior is clad in stucco and a stone veneer siding. The roof is a widely-pitched front gable roof with overhanging eaves and clad in an asphalt roll. On the south elevation, a concrete walkway and steps lead to a partial-width recessed porch. There is a tower which surmounts the main entrance and has a front gable. The primary entrance is located within the porch and consists of two doors. The windows consist of stained glass and jalousie windows. Modifications to the building include the stone veneer siding, the replacement of doors and windows. There is also a second building on the parcel lot which consists of a side gable building with overhanging eaves. Landscape features include a grass lawn.

View looking north at the building.

124 SPRUCE RD is not recommended eligible as a Chula Vista Historic Resource under any NRHP or CRHR or local criteria because of its loss of integrity. In considering the building within the historic context prepared for this survey, it does not appear to be associated with any significant themes or patterns in history and therefore not eligible for Criteria A or 1. Additionally, no significant persons were identified in association with the property and it is not recommended eligible under Criteria B or 2. Because 124 SPRUCE RD does not possess stylistic features of any architectural style, it is not a good representative of the style and is not recommended eligible under Criteria C or 3.

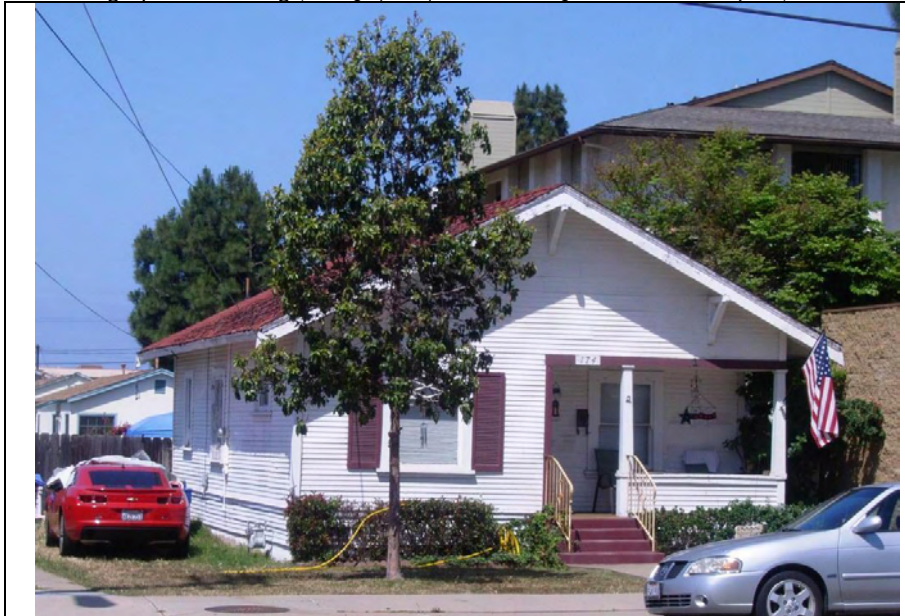
174 Third Avenue was constructed in 1910 in the Vernacular- Early Settlement style. It is a one-story single family residential building located on the west side of Third Avenue, between D and E streets. The residence has a wood frame, rectangular floor plan with a concrete foundation. The exterior is clad in horizontal wood board siding. The roof is a moderately-pitched front gable roof with widely-overhanging eaves and knee brackets and clad in asphalt shingles. On the east elevation, a concrete walkway and steps lead to a recessed partial-width porch. Squared wood posts sitting atop a low clapboard wall. The primary entrance is located within the porch and consists of a single door. The windows consist of double hung wood sash windows. There is a chimney located within the roof surface. Landscape features include a small front and side yard.

View looking west at the building.

174 THIRD AV is recommended eligible as a Chula Vista Historic Resource under NRHP, CRHR and local criteria. In considering the building within the historic context prepared for this survey, it does not appear to be associated with any significant themes or patterns in history and therefore not eligible for Criteria A or 1. Additionally, no significant persons were identified in association with the property and it is not recommended eligible under Criteria B or 2. 174 THIRD AV as an excellent local example of the Vernacular-Early Settlement style, and as such is recommended eligible as a Chula Vista Historic Resource under Criterion 3. Character defining features of the Vernacular-Early Settlement style include the wood clapboard siding, double hung wood sash windows and large knee brackets. Following the same reasons, it is also eligible for the California Register of Historical Resources and National Register of Historic Places, on the local level, under Criterion 3 (CRHR) and Criterion C (NRHP). The building retains a significant degree of its building materials dating to the period of significance, especially in comparison to other similar properties. Overall it retains a high degree of integrity, especially of design, materials, and craftsmanship.

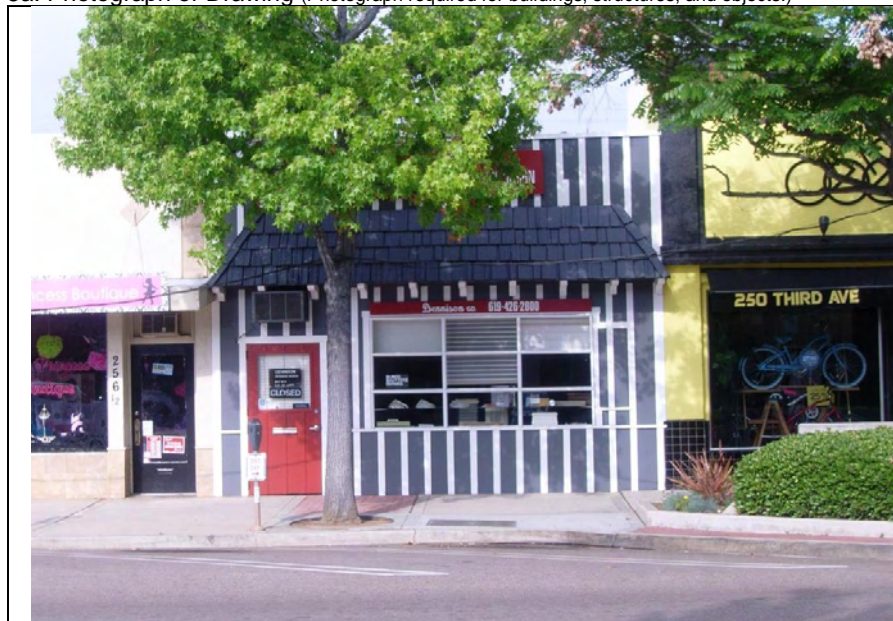
256 Third Avenue (within the parcel also assigned the address of 310 DAVIDSON ST) was constructed in 1927 in the Spanish Colonial Revival style. It is a one-story commercial building located on the west side of Third Avenue between Davidson and F streets. The commercial building has a wood frame, rectangular floor plan with a concrete foundation. The exterior is clad in board-and-batten siding. The roof is flat with a raised parapet. On the east elevation, a concrete walkway leads to an asymmetrical storefront entrance with a hipped hood. The primary entrance is located within the storefront. The window consists of one multi-light window.

View looking west at the building.

256 THIRD AVENUE (within the parcel also assigned the address of 310 DAVIDSON ST) is not recommended individually eligible as a Chula Vista Historic Resource under any NRHP or CRHR or local criteria. In considering the building within the historic context prepared for this survey, it does not appear to be associated with any significant themes or patterns in history and therefore not individually eligible for Criteria A or 1. Additionally, no significant persons or events were identified in association with the property and it is not eligible under Criteria B or 2. Although 256 THIRD AVENUE possesses some stylistic features of the Pre-War Commercial style, it is not a good individual representative of the style and is not eligible under Criteria C or 3.

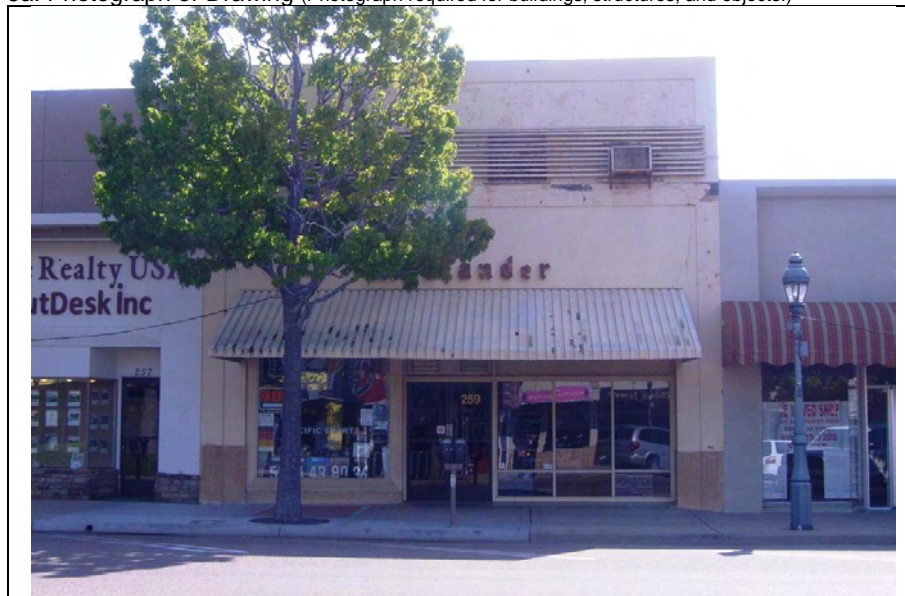
259 Third Avenue was constructed in 1939 in the Pre-War Commercial style. It is a two-story commercial building located on the east side of Third Avenue between F and Davidson streets. The commercial building has a wood frame, rectangular floor plan with a concrete foundation. The exterior is clad in stucco and a tile water table. The roof is flat with a raised parapet. On the west elevation, a concrete walkway leads to a full-width storefront flanked by glass plate windows. There is a metal awning shed roof. The primary entrance is located within the porch and consists of a glass door. The windows consist of glass plate storefront windows. There is a sign on the upper portion of the building which reads, "Highlander."

View looking east at the building.

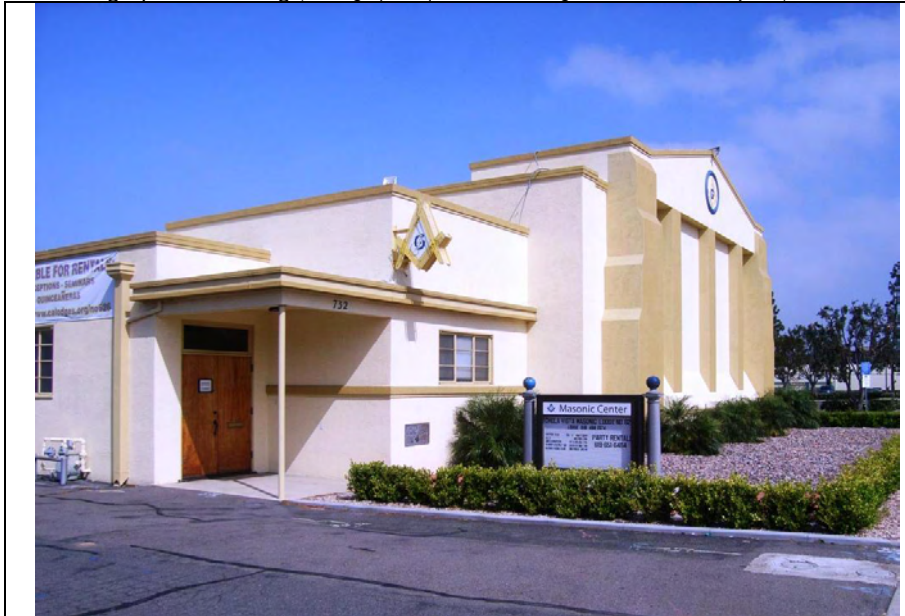
P5a. Photograph or Drawing (Photograph required for buildings, structures, and objects.)

View looking west at the building.

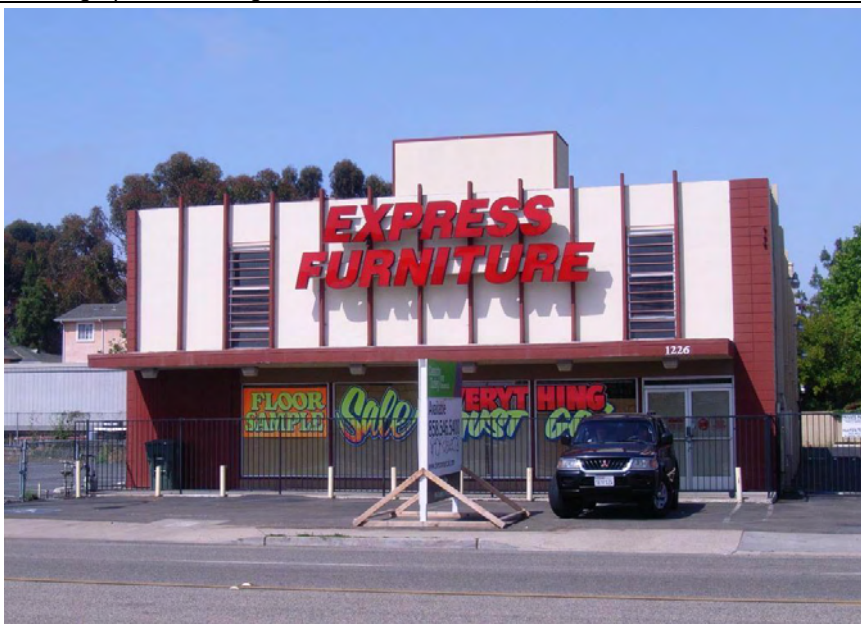
P5a. Photograph or Drawing (Photograph required for buildings, structures, and objects.)

1226 Third Avenue was constructed in 1959 in the Modern non-residential style. It is a two-story commercial building located on the west side of Third Avenue between Palomar and Oxford streets. The commercial building has a wood frame, rectangular floor plan with a concrete foundation. The exterior is clad in stucco, tile veneer and vertical wood board siding. The roof is a flat roof with a raised parapet. On the east elevation, a concrete walkway leads to a full-width storefront that is covered by a cantilevered hood. The primary entrance is located on the east elevation and consists of two metal storefront doors. The windows consist of aluminum sash windows covered in vents. There are also fixed glass plate windows on the east elevation. Decorative elements of the building include vertical posts over the hood. There appear to be no modifications to the building. Landscape features include a parking lot.

View looking west at the building.

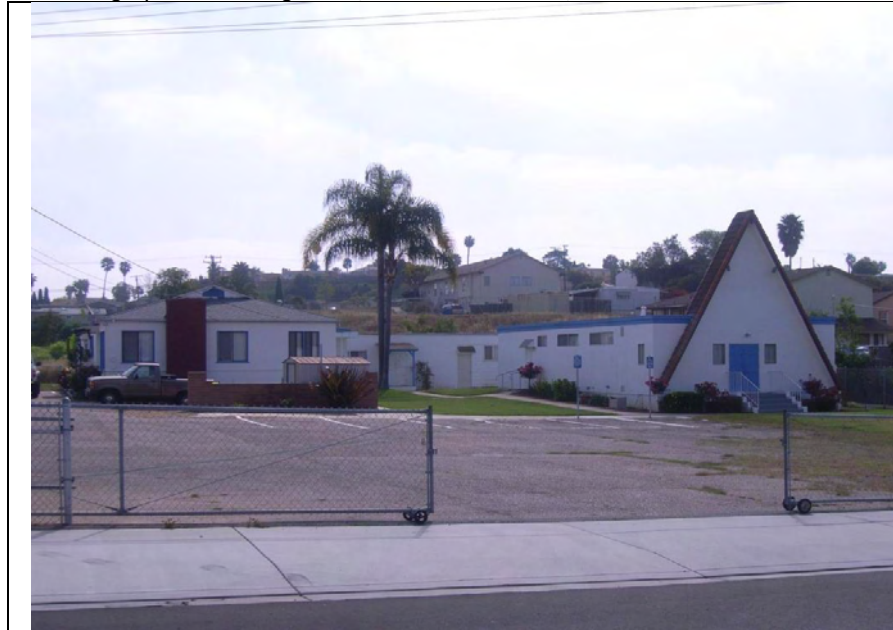
P5a. Photograph or Drawing (Photograph required for buildings, structures, and objects.)

View looking east at the church.

1225 TOBIAS DR is not recommended eligible as a Chula Vista Historic Resource under any NRHP or CRHR or local criteria. In considering the building within the historic context prepared for this survey, it does not appear to be associated with any significant themes or patterns in history and therefore not eligible for Criteria A or 1. Additionally, no significant persons were identified in association with the property and it is not recommended eligible under Criteria B or 2. Although 1225 TOBIAS DR possesses some stylistic features of the Modern style, it is not a good representative of the style and is not recommended eligible under Criteria C or 3.

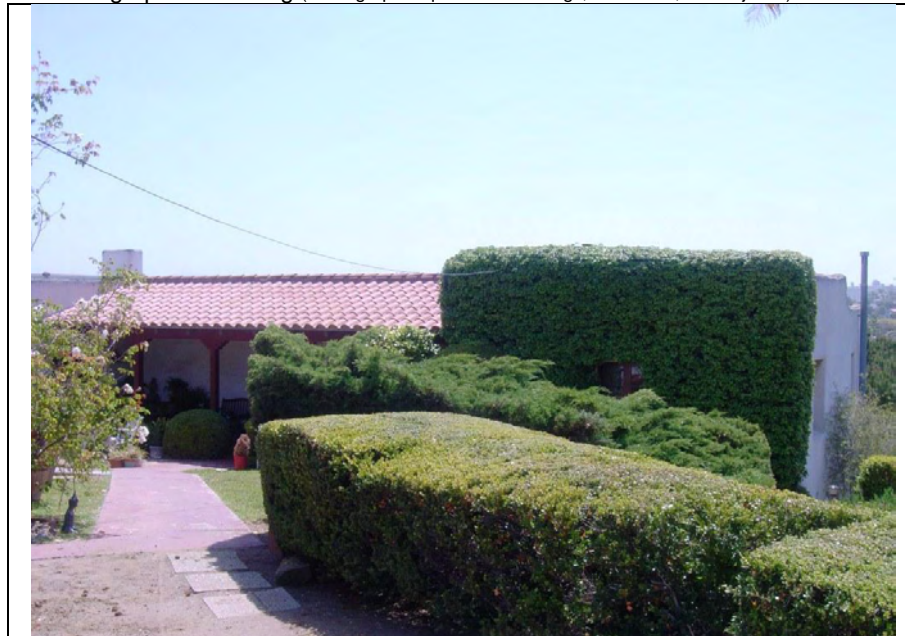
P5a. Photograph or Drawing (Photograph required for buildings, structures, and objects.)

12 Toyon Lane was constructed in 1928 in the Mediterranean Revival style. It is a one-story single family residential building located on the south side of Toyon Lane. The residence has a wood frame, rectangular floor plan with a concrete foundation. The exterior is clad in stucco siding. The roof is flat with a shed roof extension over the walkway. The primary entrance is located within the porch and consists of a single wood door. The windows consist of wood casement windows. No other features of the façade could be seen from the road at the time of the survey. There is one chimney located within the roof surface. There appear to be no modifications to the building. Landscaping features include large bushes at the front façade of the building.

View looking east at the building.

12 TOYON LN is recommended eligible as a Chula Vista Historic Resource under NRHP, CRHR and local criteria. In considering the building within the historic context prepared for this survey, it does not appear to be associated with any significant themes or patterns in history and therefore not eligible for Criteria A or 1. 12 TOYON LN is eligible as a Chula Vista Historic Resource under Criterion 2 for its association with G.W. Anderson, who made significant contributions locally as an important member of the community. Anderson was director of the 1935 California Pacific International Exposition at Balboa Park, the past president of the San Diego Chamber of Commerce. Anderson had 12 Toyon Lane built for him by Ray Sanford, and lived here until his death in 1934. 12 TOYON LN as an excellent local example of the Spanish Colonial Revival style, and as such is recommended eligible as a Chula Vista Historic Resource under Criterion 3. Character defining features of the Spanish Colonial Revival style include the red clay tile roof, recessed walkway, stucco wall surface. Following the same reasons, it is also eligible for the California Register of Historical Resources and National Register of Historic Places, on the local level, under Criterion 3 (CRHR) and Criterion C (NRHP). The building retains a significant degree of its building materials dating to the period of significance, especially in comparison to other similar properties. Overall it retains a high degree of integrity, especially of design, materials, and craftsmanship.
